# **INDOOR AIR QUALITY ASSESSMENT**

**Middleton Town Hall  
48 South Main Street  
Middleton, MA**

Prepared by:  
Massachusetts Department of Public Health  
Bureau of Environmental Health  
Indoor Air Quality Program  
September 2016

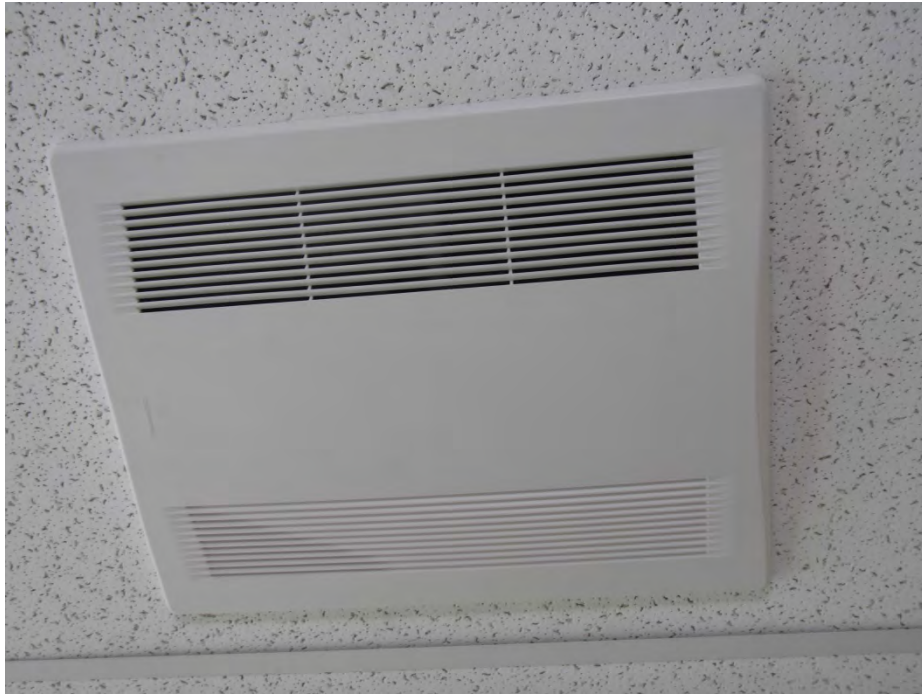
**Picture 1**

The MTH *does not* currently have mechanical fresh air ventilation in most occupied areas. The Collector’s and Treasurer’s offices have been retrofitted to include ceiling-mounted energy recovery ventilator (ERV) units which supply tempered fresh air and exhaust stale air in these two areas (Pictures 1 and 2). MTH staff reported that these units operate continuously during occupied hours. All other areas rely on open windows or window AC units to bring in fresh air. In addition, the second floor restroom was noted to lack local exhaust ventilation.

**Energy Recovery Ventilator (ERV)**

3. Continue to utilize the two ceiling-mounted ERV units to provide fresh air and exhaust ventilation. Maintain these units according to manufacturer recommendations.

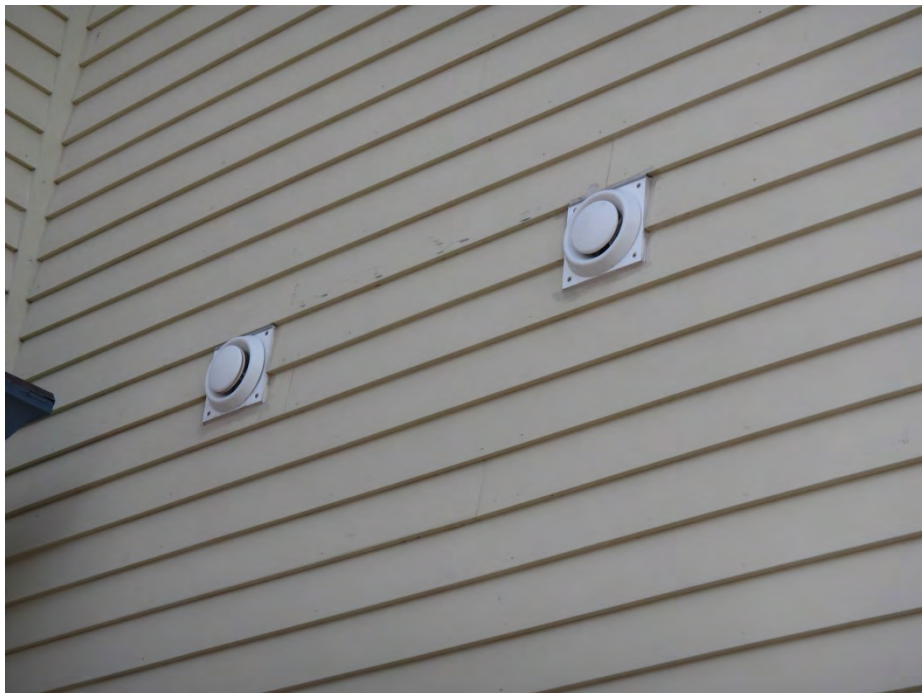
**Picture 2**

**Intake and exhaust vents for ERV unit**

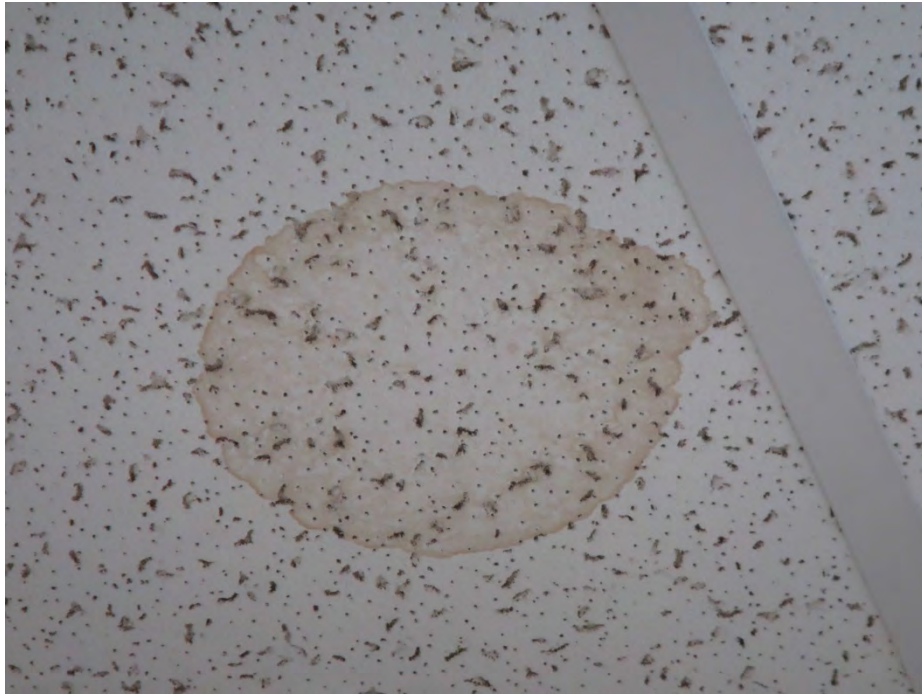
**Picture 3**

BEH staff noted water-damaged ceiling tiles in some areas (Picture 3). MTH staff reported that these stains were likely from historic leaks. The US Environmental Protection Agency (US EPA) and the American Conference of Governmental Industrial Hygienists (ACGIH) recommends that porous materials (e.g., wallboard, ceiling tiles) be dried with fans and heating within 24 to 48 hours of becoming wet (US EPA, 2008; ACGIH, 1989). If porous materials are not dried within this time frame, mold growth may occur.

**Water-damaged ceiling tile**

7. Replace water-damaged ceiling tiles. Monitor these areas to confirm that historic water leaks have been properly repaired.
8. Consider installing exhaust fans in restrooms which are not equipped with them to remove odors and moisture outdoors.

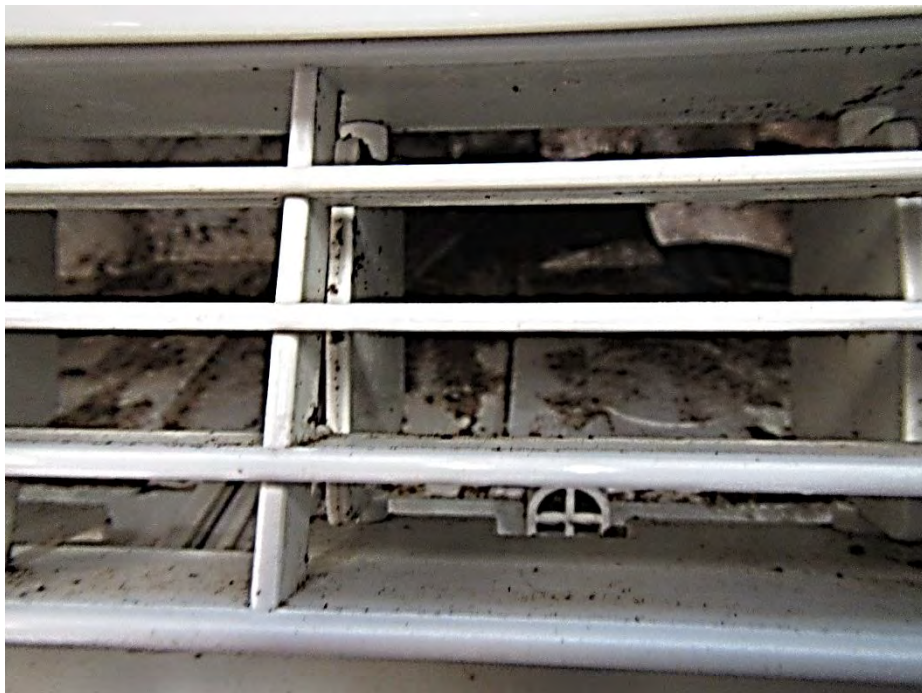
**Picture 4**

The Collector's office was observed to have a window AC unit which had accumulated debris and possible microbial colonization in the supply vent (Picture 4). These units should be cleaned regularly to avoid dust/debris accumulation. Windows should remain closed during humid weather while AC units are operating to avoid chronic condensation and microbial growth. In addition, any washed filters should be allowed to dry completely before replacing and operating the units.

**AC unit with debris/possible microbial colonization**

6. Thoroughly clean the AC units of any accumulated dust and debris. Follow manufacturer recommendations for proper maintenance including regular filter cleaning.

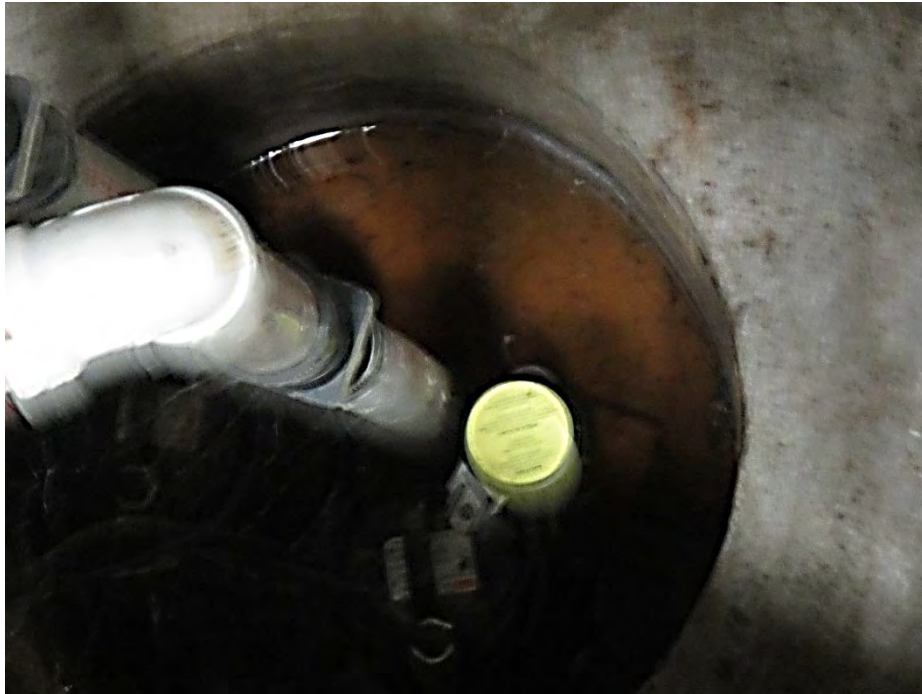
**Picture 5**

The basement was noted to have an open sump pump (Picture 5). MDPH typically recommends having a tightly sealed sump cover to prevent moisture, odors, and pests from entering the building.

**Open sump pit with no cover**

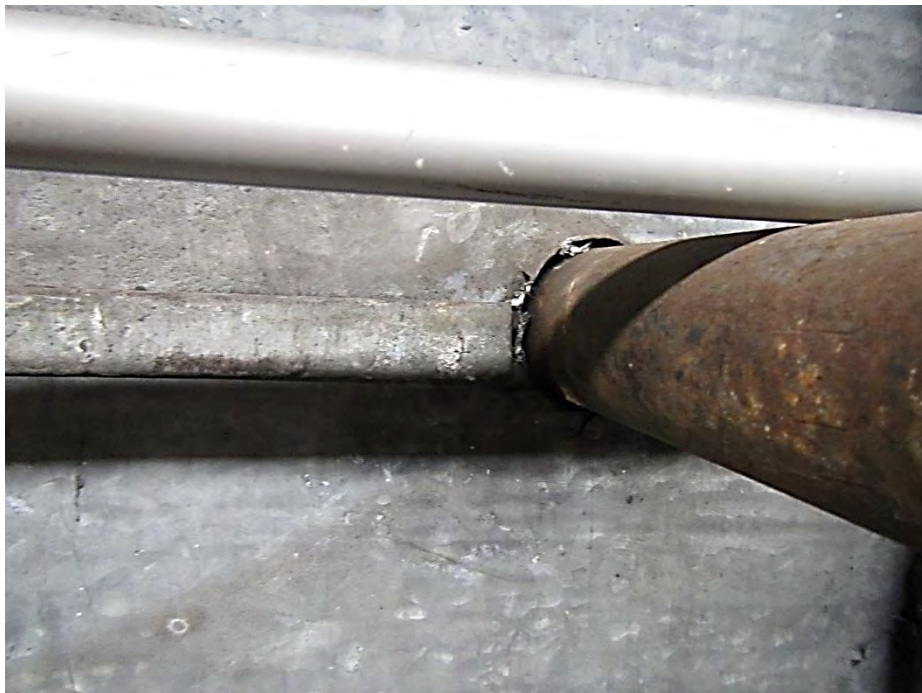
**Picture 6**

The old gravity ventilation system should be inspected for pathways which lead to occupied spaces. Some gaps around piping in the mixing chambers were noted (Picture 6). These gaps may allow moisture and odors to travel to occupied areas if the old vents are not sealed properly. Some abandoned vents in occupied areas were observed to be blocked with a porous material (Picture 7). These vents should be sealed with either cement board or other nonporous building material and caulking to render them airtight and moisture resistant.

**Abandoned gravity ventilation chamber with gaps around old steam pipes**

9. Inspect the old gravity ventilation system for any gaps in the mixing chamber which may lead to occupied areas. Also, consider replacing material used to block the old vents with cement board or other nonporous material that is resistant to moisture. Use caulking or sealant to render these vent openings and gaps airtight to avoid them serving as pathways from the unconditioned basement area.

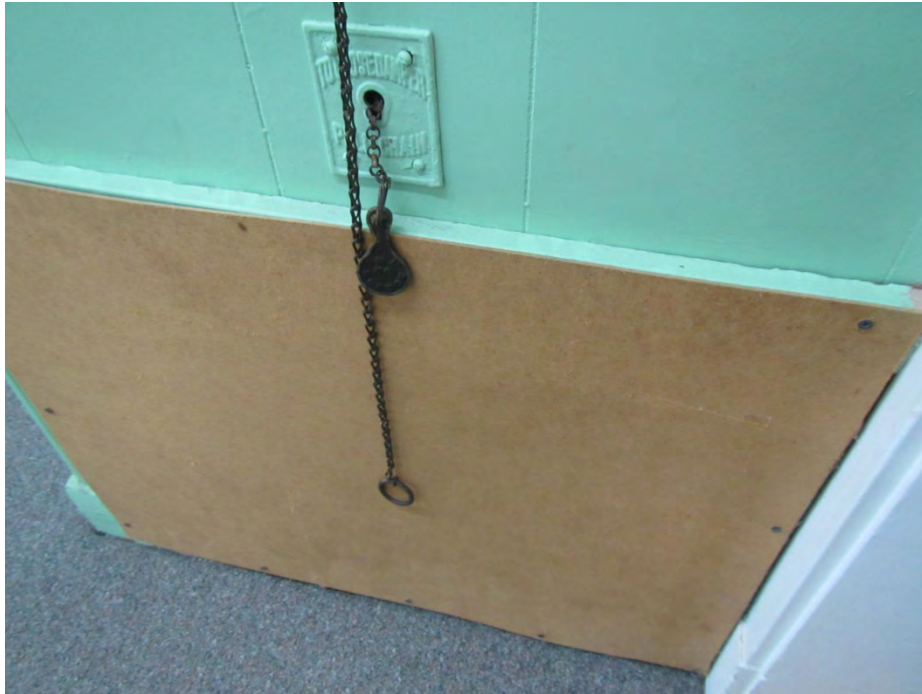
**Picture 7**

**Abandoned gravity wall vent blocked with porous fiber board**

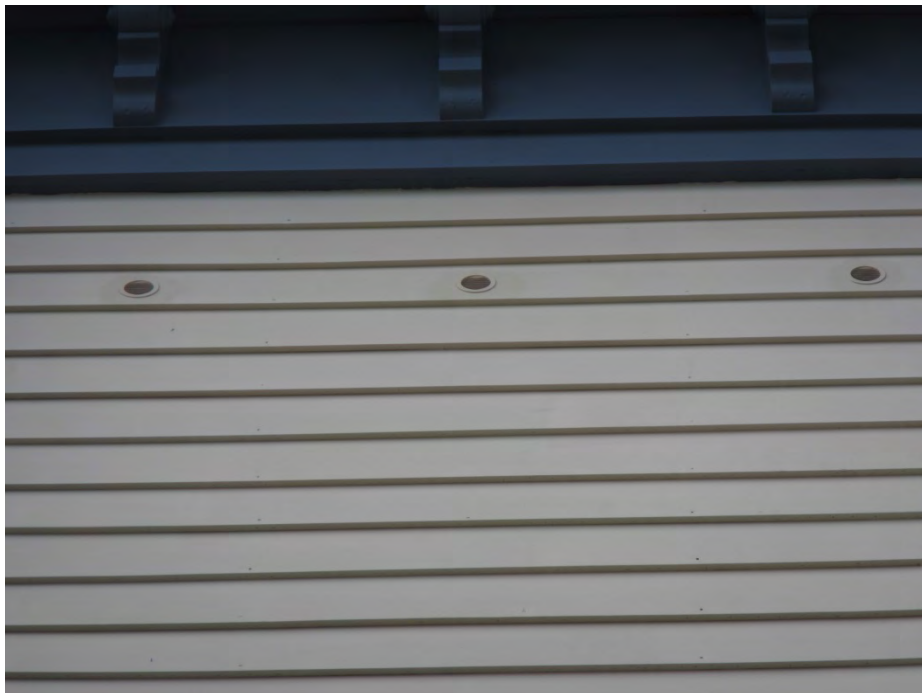
**Picture 8**

**Wall cavity vents on the exterior of the MTH**

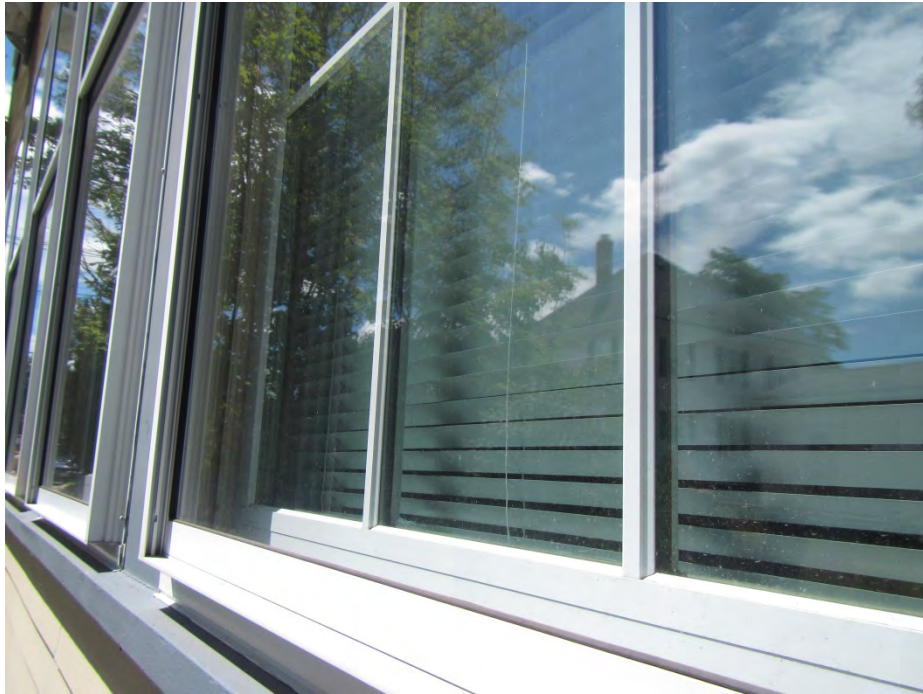
**Picture 9**

Administrator office suite. This confirmed reports that the odor is noted in the morning in East facing spaces, in the early afternoon in South facing spaces, and then in later afternoon in Western facing offices. MTH staff reported that new window jamb liners were previously installed and that storm windows were installed approximately 3 years ago. This coincided with the reports of when the odor first began. It is likely that the placement of storm windows over the existing windows and plastic jamb liners created a condition where excessive heat is allowed to build up and accelerate the off gassing of the softer window jamb liners (Pictures 9 and 10). The window screens may be a contributing factor as well since they are also exposed to this solar heating. The source of the odor is likely an additive or plasticizer that is semi-volatile in nature thus cannot be measured during TVOC testing. Also, many plastic additives have very low odor thresholds so that they will be detected by smell long before reaching levels of concern. However, low levels of TVOCs and semi-volatile organic compounds (SVOCs) can have irritant effects.

**South facing windows with storm windows closed over aluminum clad/wood windows**

1. Keep tops and bottoms of storm windows open to allow for ventilation between storm windows and building windows. This should prevent odors due to excessive heat buildup and off gassing from soft vinyl window jamb liners and or window screens.

1. Consider removing the storm windows and installing replacement windows on the South and Western sides of the MTH and other areas affected by odor (Town Manager's suite).
2. Consult with an HVAC engineer to determine the feasibility of installing an air handling unit for fresh air supply and exhaust ventilation throughout the MTH.

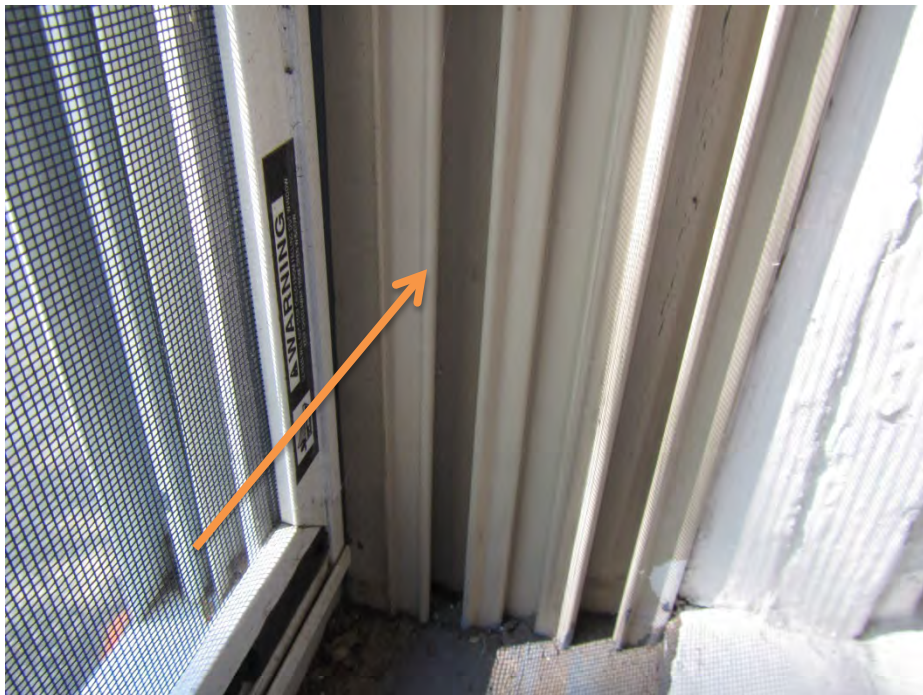
**Picture 10**

**Flexible vinyl jamb liner that is heated between storm and building windows**

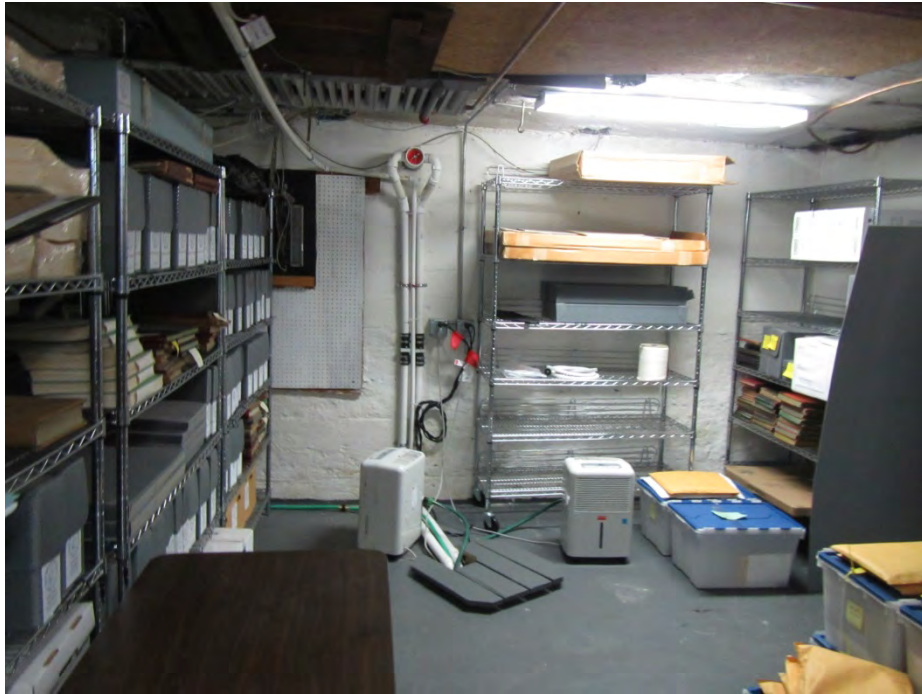
**Picture 11**

Dehumidifiers and air purifiers were noted in the MTH (Picture 11). These appliances should be maintained in accordance with manufacturer's instructions, including filter changing/cleaning, so that they don't become a source of irritants.

**Dehumidifiers in use in the basement of the MTH**

11. Consider adopting an integrated pest management (IPM) plan to effectively control reported mice issues and other pests. The guideline can be found at:  
<http://www.mass.gov/eea/docs/agr/pesticides/publications/ipm-kit-for-bldg-mgrs.pdf>
12. Ensure that dehumidifiers and air purifiers are maintained in accordance with manufacturer's instructions.
13. Keep plants in good condition, avoid overwatering, and avoid placing them on porous items such as carpets or paper.
14. Consider installing a sealed sump pump cover to prevent moisture, odors, and pests from entering the building.
15. Refer to resource manual and other related IAQ documents located on the MDPH's website for further building-wide evaluations and advice on maintaining public buildings. These documents are available at: <http://mass.gov/dph/iaq>.
